**Site 58 – Releiz Creek**

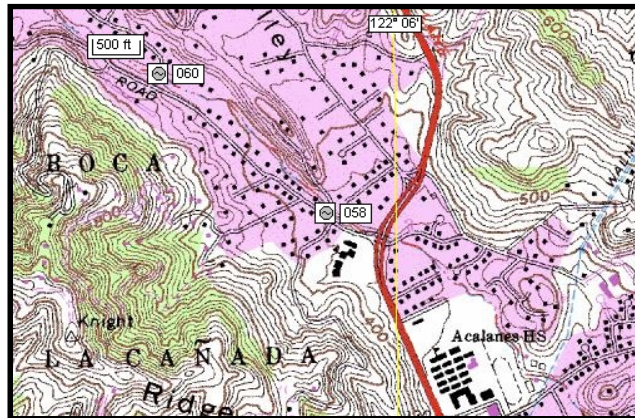
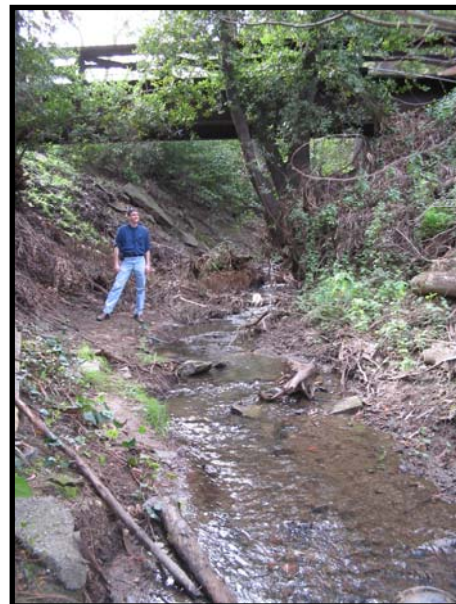
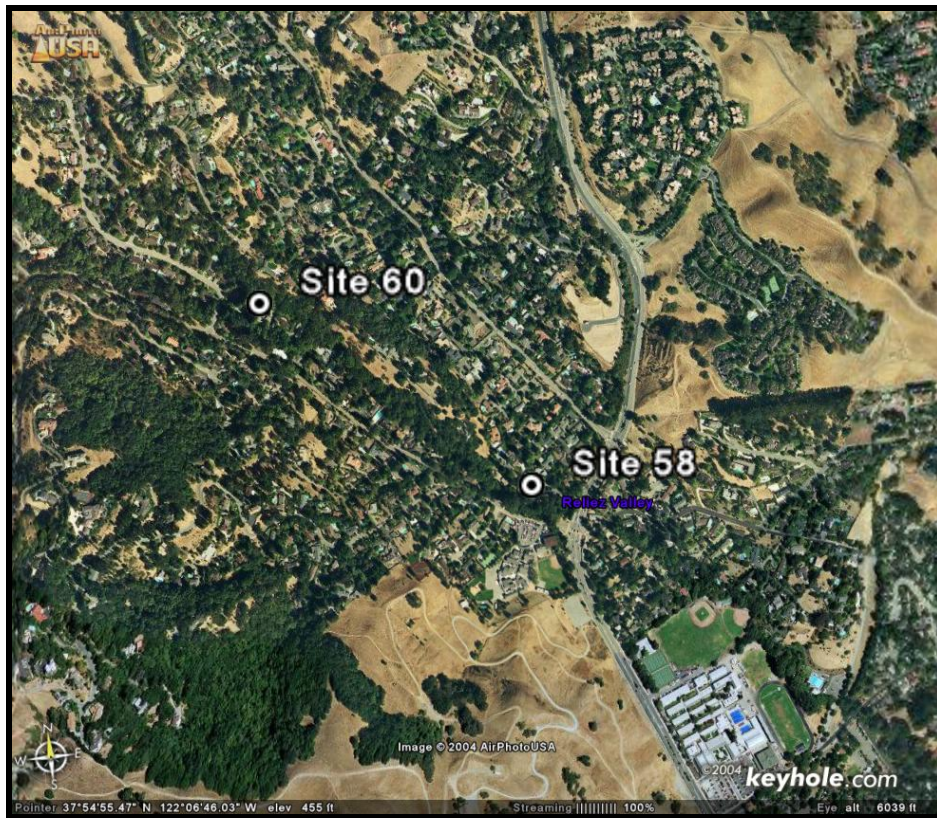
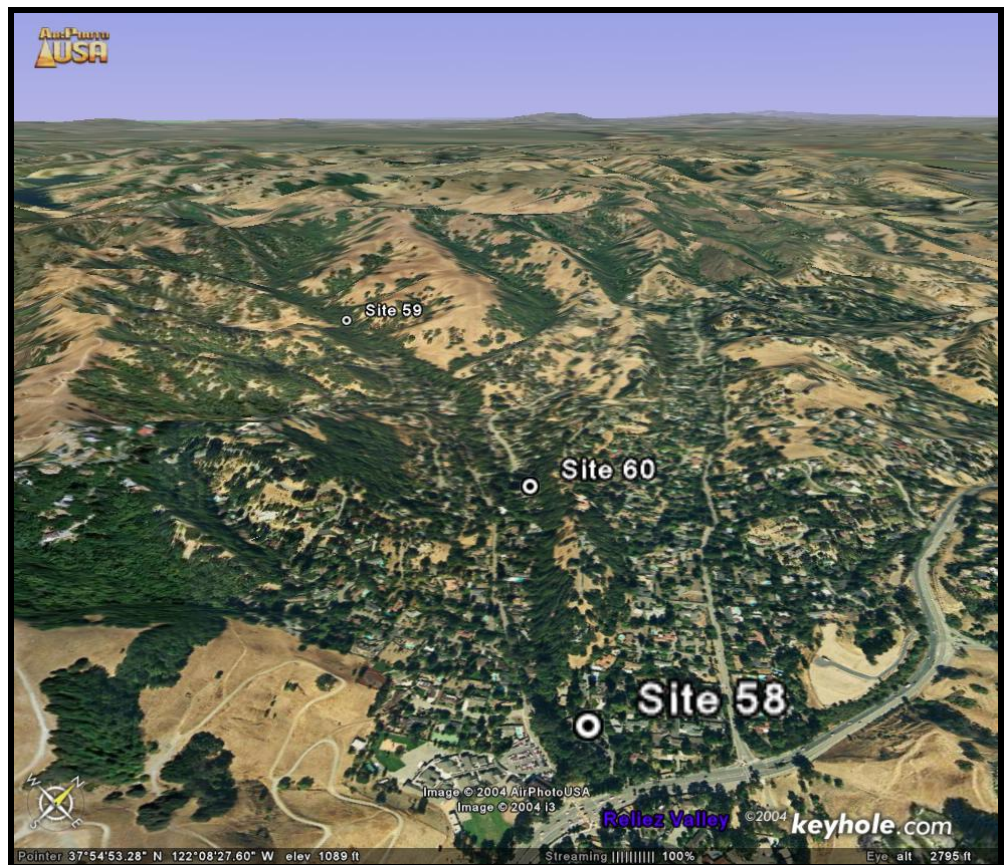
**RISK JUSTIFICATION:** Primary and secondary attributes are mixed. High risk class assignment due to confinement, evidence of historic incision. Coarse bed materials suggest a low risk for incision, although confinement indicates that erosion potential during large storms may be significant.

**SITE NOTES:** Channel incised about 15-18 feet into a small, confined valley along older sub-division. Road is adjacent to channel. Clear signs of bank instability evident through informal hardening efforts (e.g. brick, old asphalt, log revetments etc.).
