Site 74 – Briones Valley Headwaters

Attachment 4, Appendix B

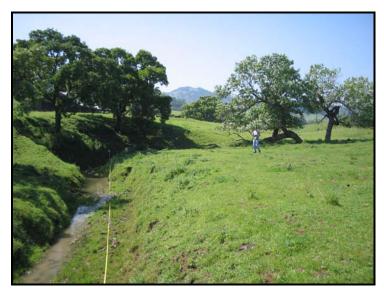
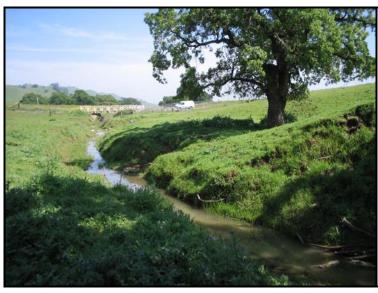
RISK JUSTIFICATION: Primary attributes are High. Fine substrate combined with evidence of localized bank erosion and significant channel incision under existing conditions; moderate supply of sediment will help maintain an alluvial mantle and prevent incision, although reduction in supply could destabilize the channel; high width/depth ratio may be a result of channel widening associated with cattle-driven sedimentation.

SITE NOTES: Locally steep eroded bluffs providing a moderate amount of sediment supply. Banks mostly stable and well vegetated. Occasional boulders and bedrock blocks in channel. Channel incised about 9 feet into valley floor.
