C.6 CONSTRUCTION CASE STUDY

Out of compliance site goes bankrupt

Elliot Wier, City of Fremont

March 30, 2022

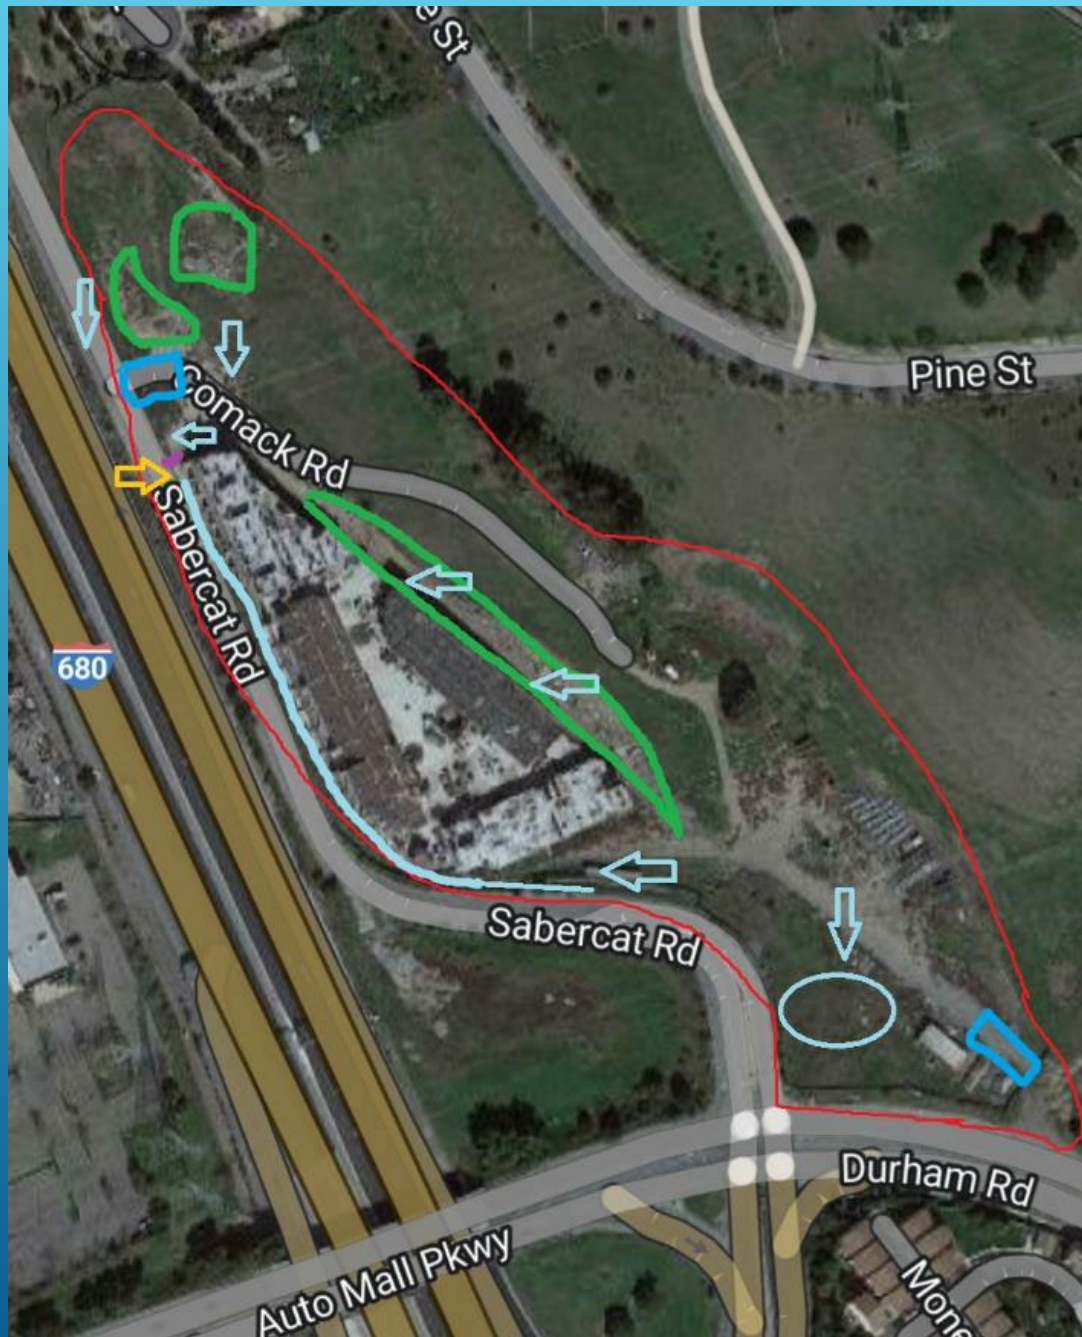
HILLSIDE NOI SITE OVERVIEW (CONTRACTOR ON SITE)

Ongoing challenges during inspection included:

- Slope stabilization
- Exit stabilization
- Runoff management

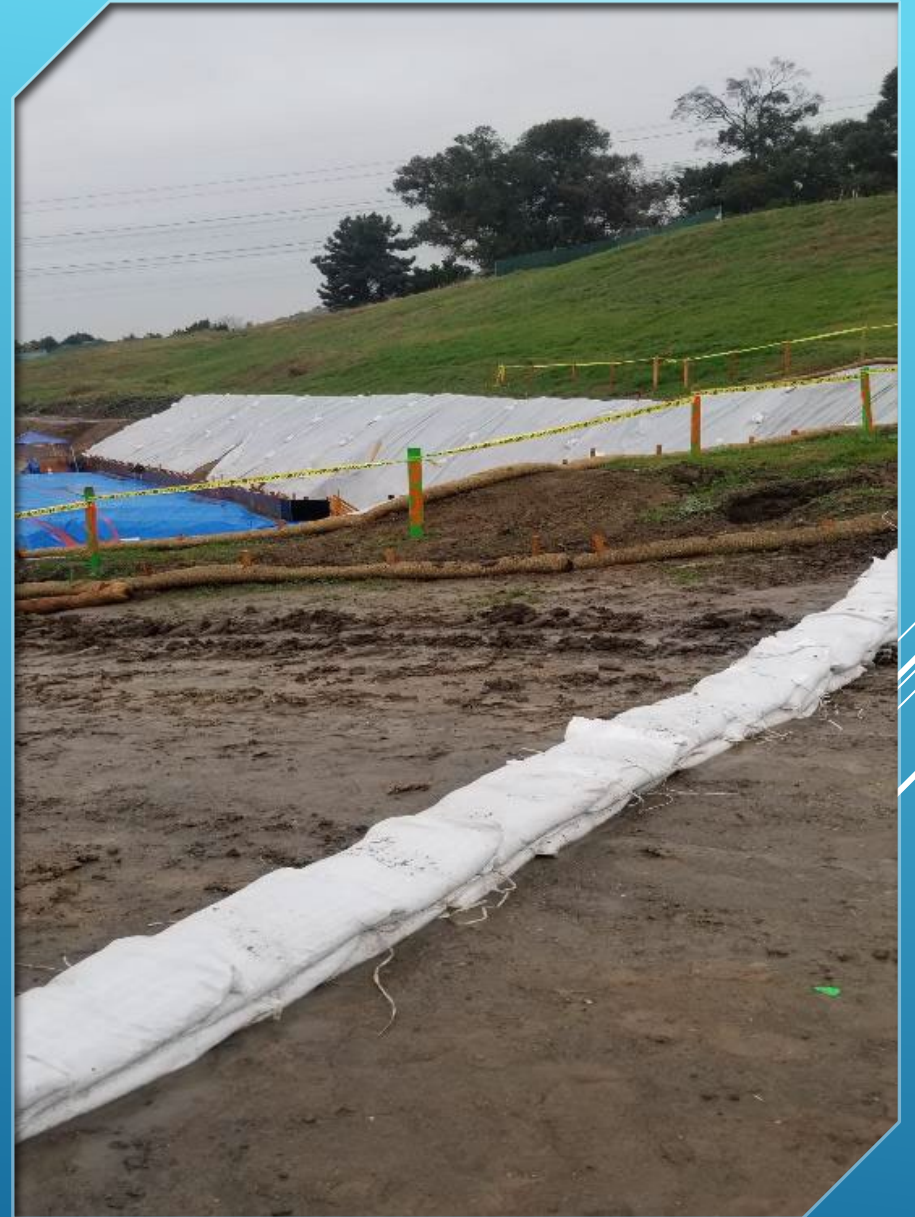
SLOPE STABILIZATION

Steep slope cut into hillside drains to central location on the low side of the site by property line. QSP chose to cover slope with plastic, this created two major issues.

1: Managing the runoff from the plastic.

2: Maintenance issues during high winds and photodegradation.

* Better option would be tacked jute netting with possible hydroseed and fiber roll at the slope toe.

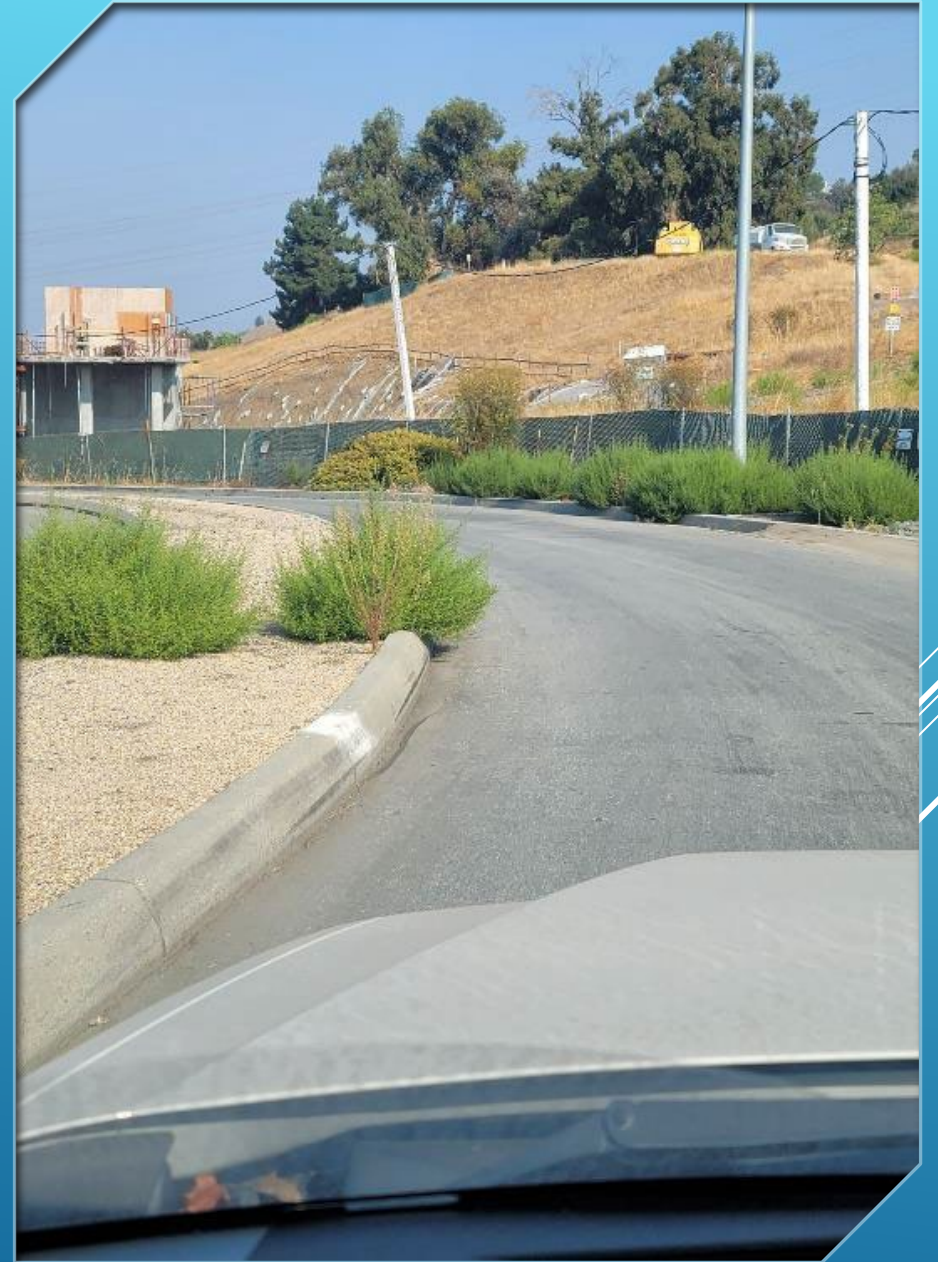
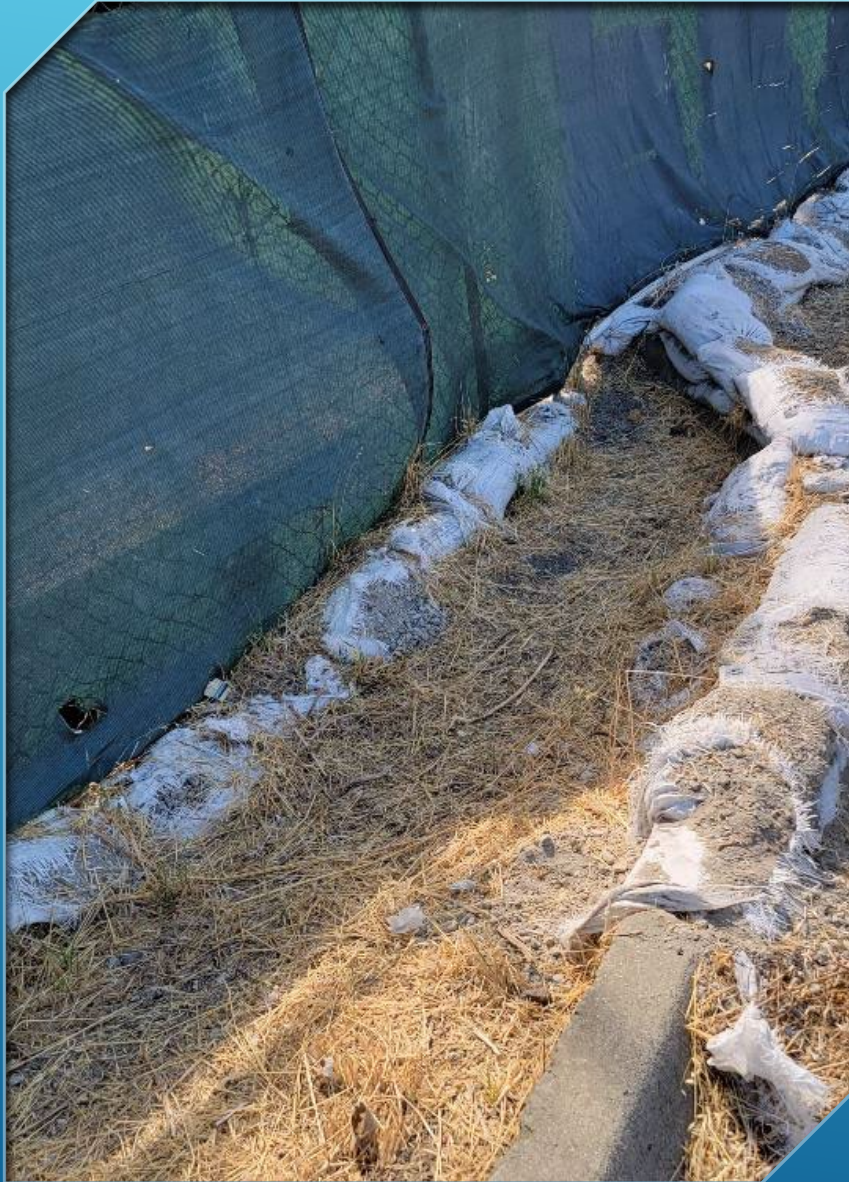
SLOPE STABILIZATION

Steep slope cut into hillside drains to central location on the low side of the site by property line. QSP chose to cover slope with plastic, this created two major issues.

1: Managing the runoff from the plastic.

2: Maintenance issues during high winds and photodegradation.

* Better option would be tacked jute netting with possible hydroseed and fiber roll at the slope toe.

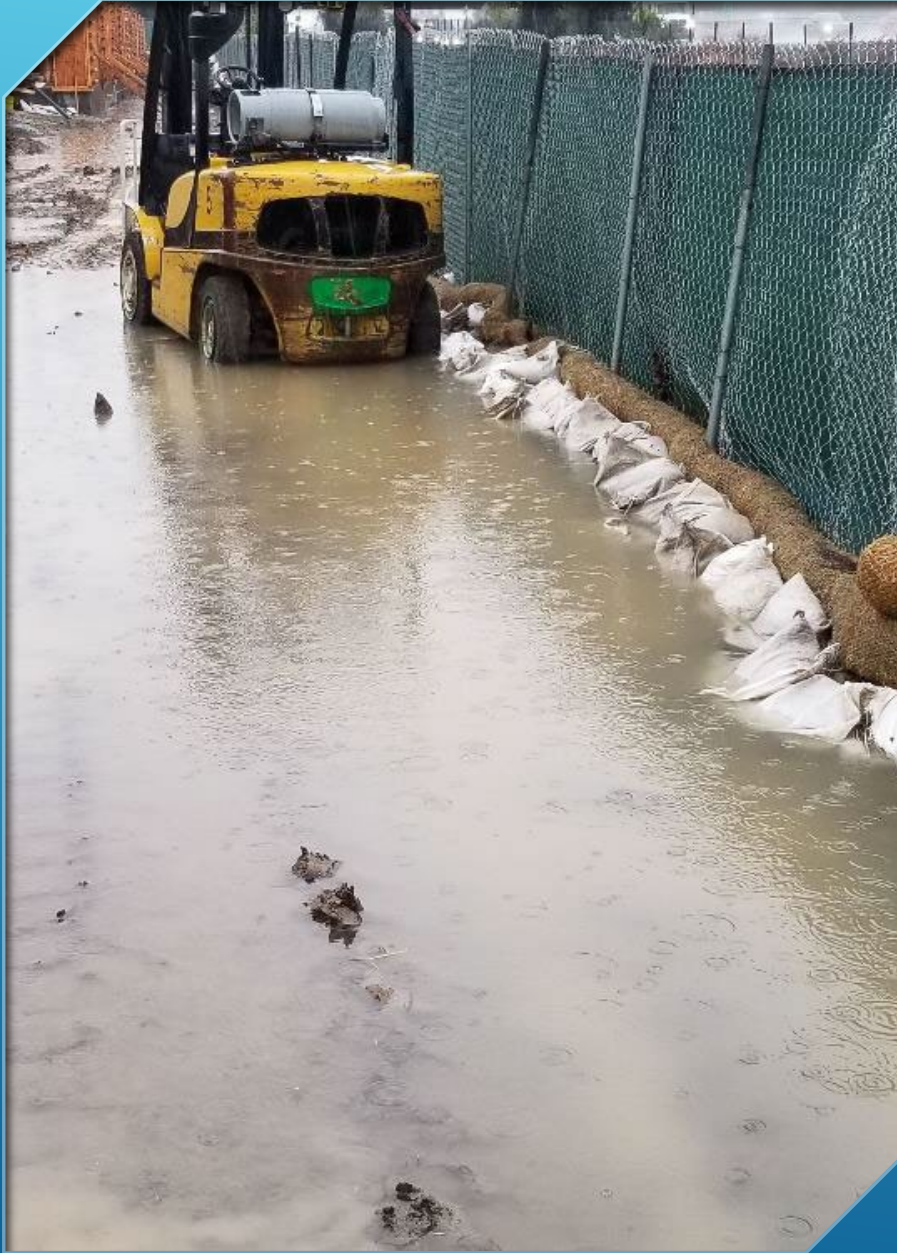
PERIMETER CONTROLS

Perimeter controls were installed to 1: keep runoff from leaving the site and 2: filter and slow down any runoff leaving the site to meet NTU action levels. Site was failing to test runoff.

BMPs used were rock/sandbags built up around the low points of the site in combination with fiber rolls.

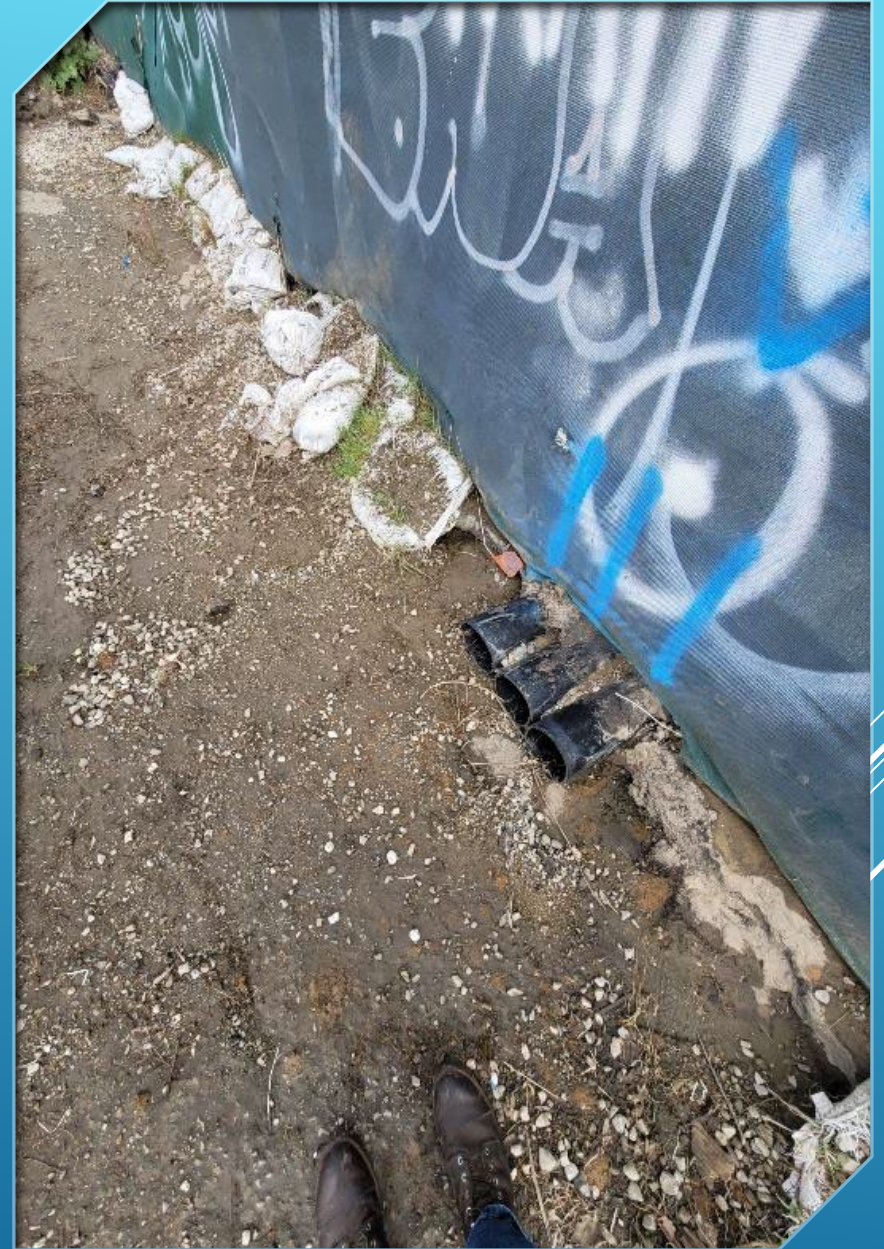
PERIMETER CONTROLS

70% of the site flows to this location causing ponding onsite and challenges preventing sediment laden runoff.

Other issues are storing material and equipment in this low area.

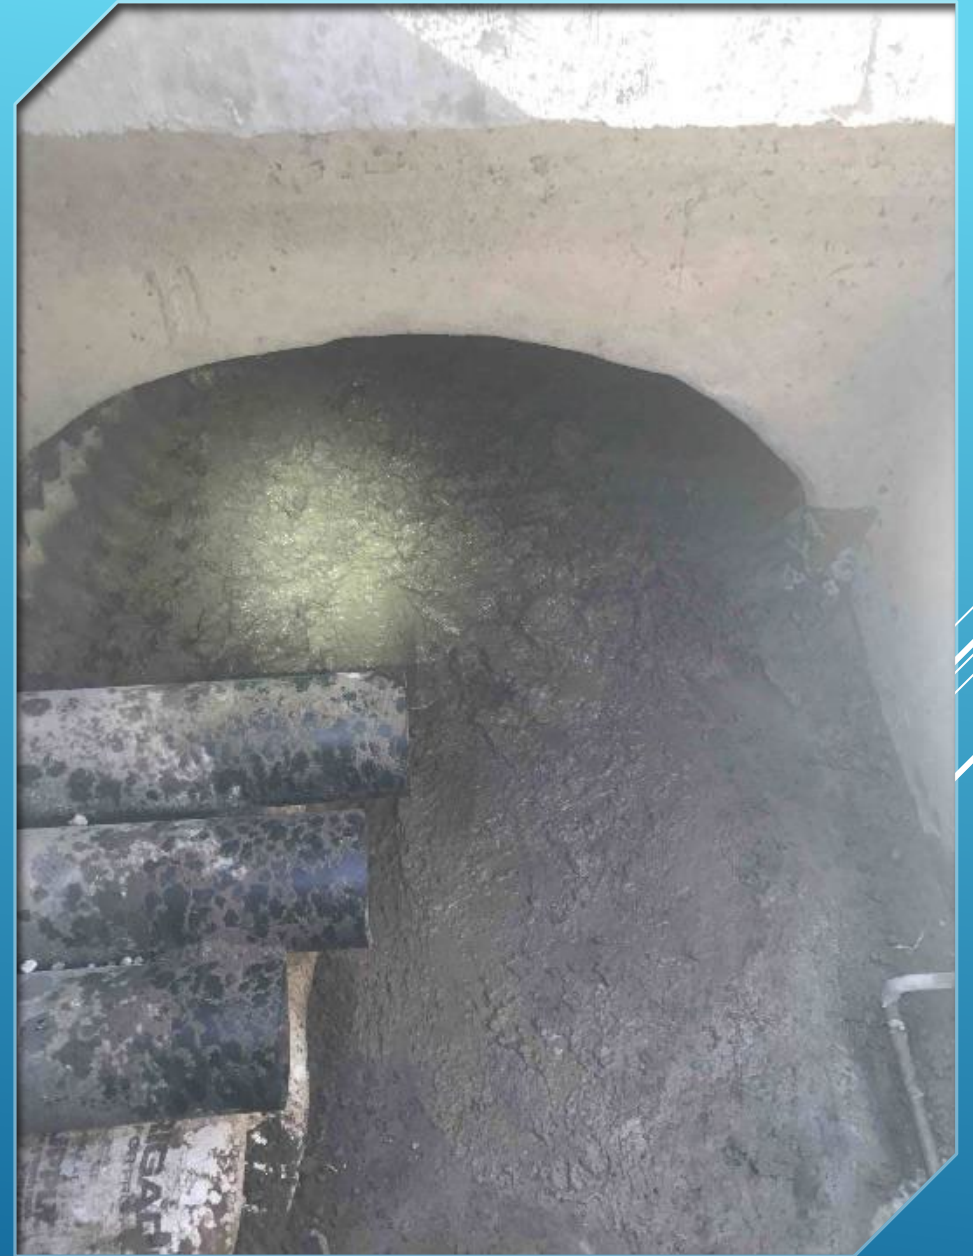
MANAGING SITE RUNOFF

Most of the site drains to one location. An onsite catch basin/culvert was sealed and three 3" pipes were installed on the outside of the property line to discharge collected street runoff to MS4. Issues found during inspection.

1: Failing to maintain perimeter controls and slope management was causing sediment laden water to leave the site and discharge into these 3" pipes.

2: Failing to maintain area around the pipes causing potential sediment laden runoff and clogging of the pipe structures.

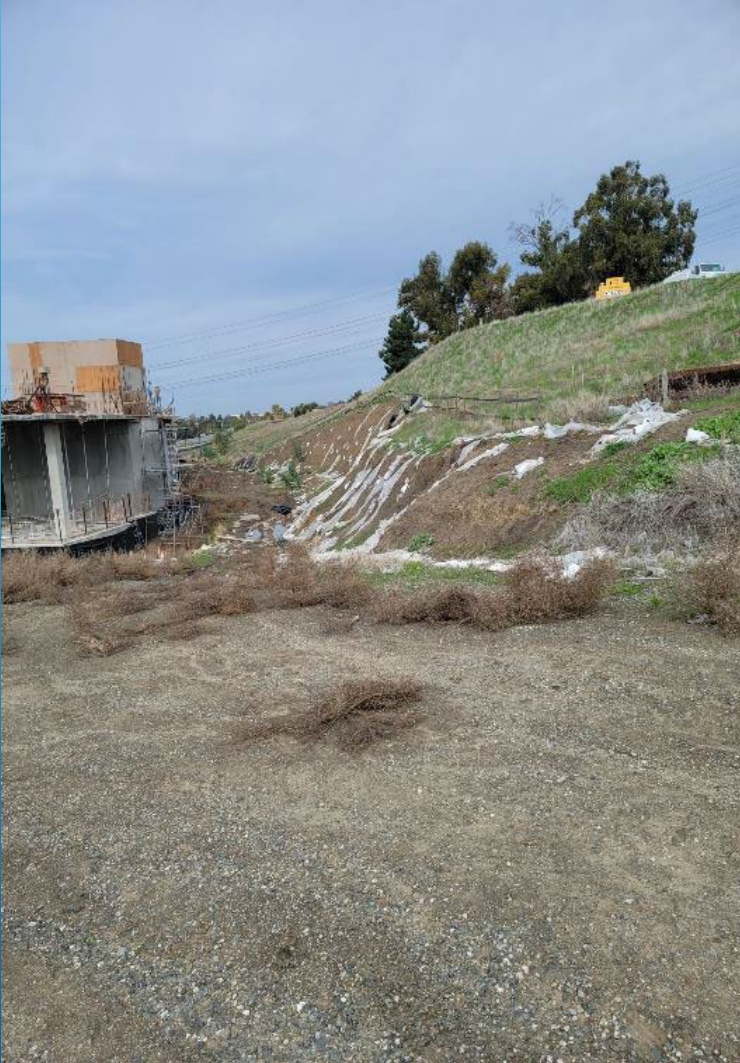
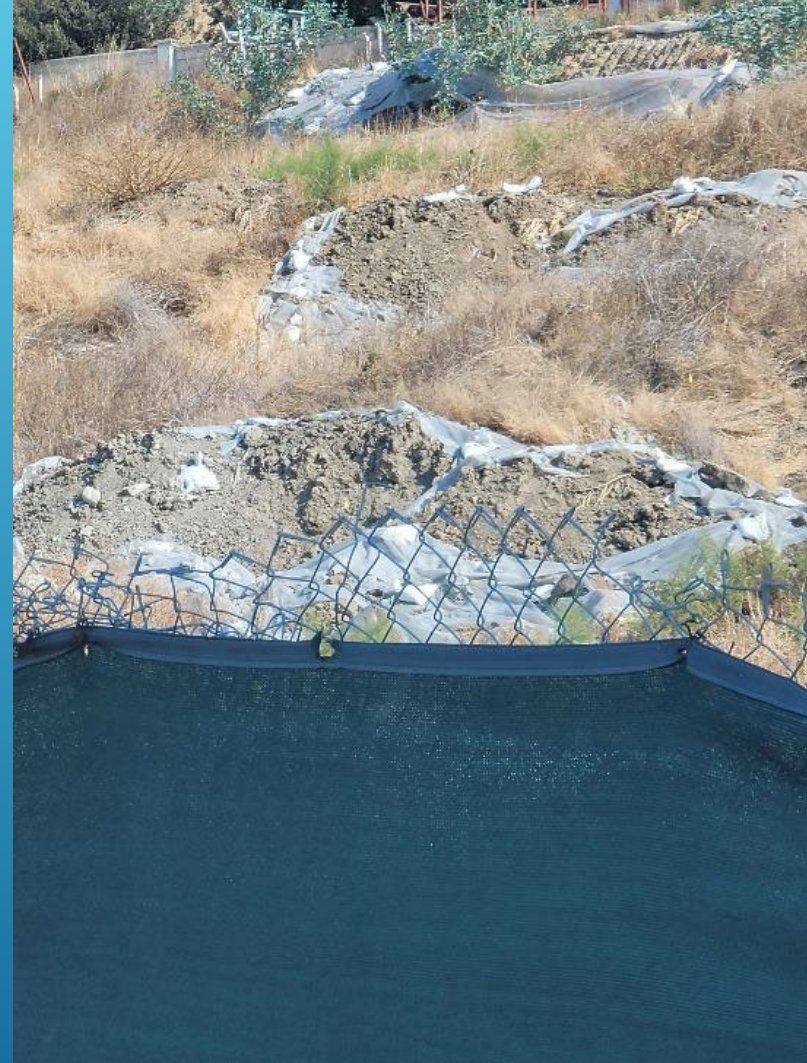
SLOPE STABILIZATION

Failure to maintain these BMPs was causing significant amounts of sediment laden discharge along with sand bag material and plastic. This also was causing the discharge pipes to clog flooding the street during heavy rains.
