**Site 58 – Releiz Creek**

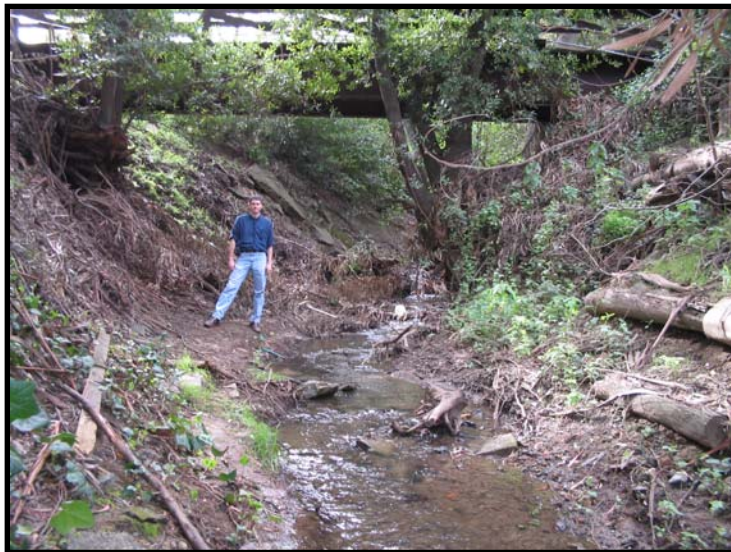
**RISK JUSTIFICATION:** Primary and secondary attributes are mixed. High risk class assignment due to confinement, evidence of historic incision. Coarse bed materials suggest a low risk for incision, although confinement indicates that erosion potential during large storms may be significant.

**SITE NOTES:** Channel incised about 15-18 feet into a small, confined valley along older sub-division. Road is adjacent to channel. Clear signs of bank instability evident through informal hardening efforts (e.g. brick, old asphalt, log revetments etc.).
