Site 74 – Briones Valley Headwaters

Attachment 4, Appendix B

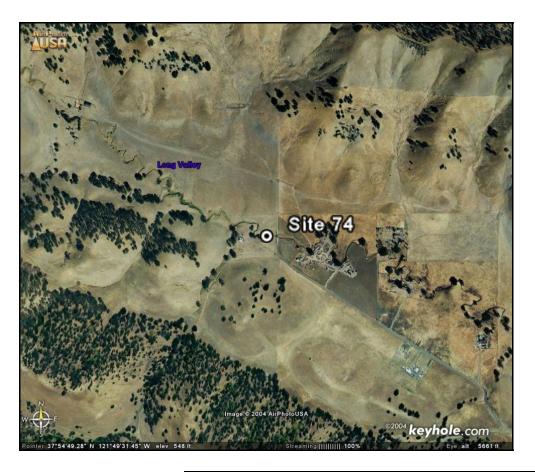
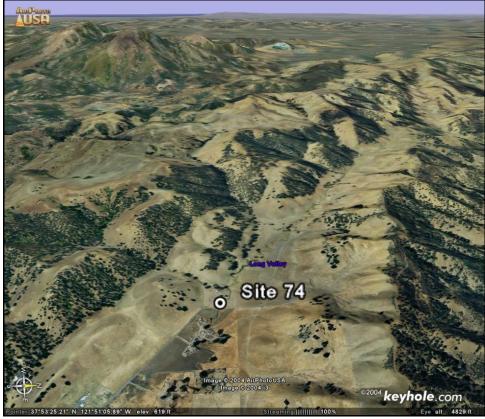
SITE NOTES: Locally steep eroded bluffs providing a moderate amount of sediment supply. Banks mostly stable and well vegetated. Occasional boulders and bedrock blocks in channel. Channel incised about 9 feet into valley floor.
