Pollutants of Concern Report: Accomplishments in Water Year 2017 and Allocation of Effort for Water Year 2018

*In Compliance with NPDES Permit Provision C.8.h.iv
Municipal Regional Stormwater Permit 2.0 (Order R2 2015 0049)*

October 2017

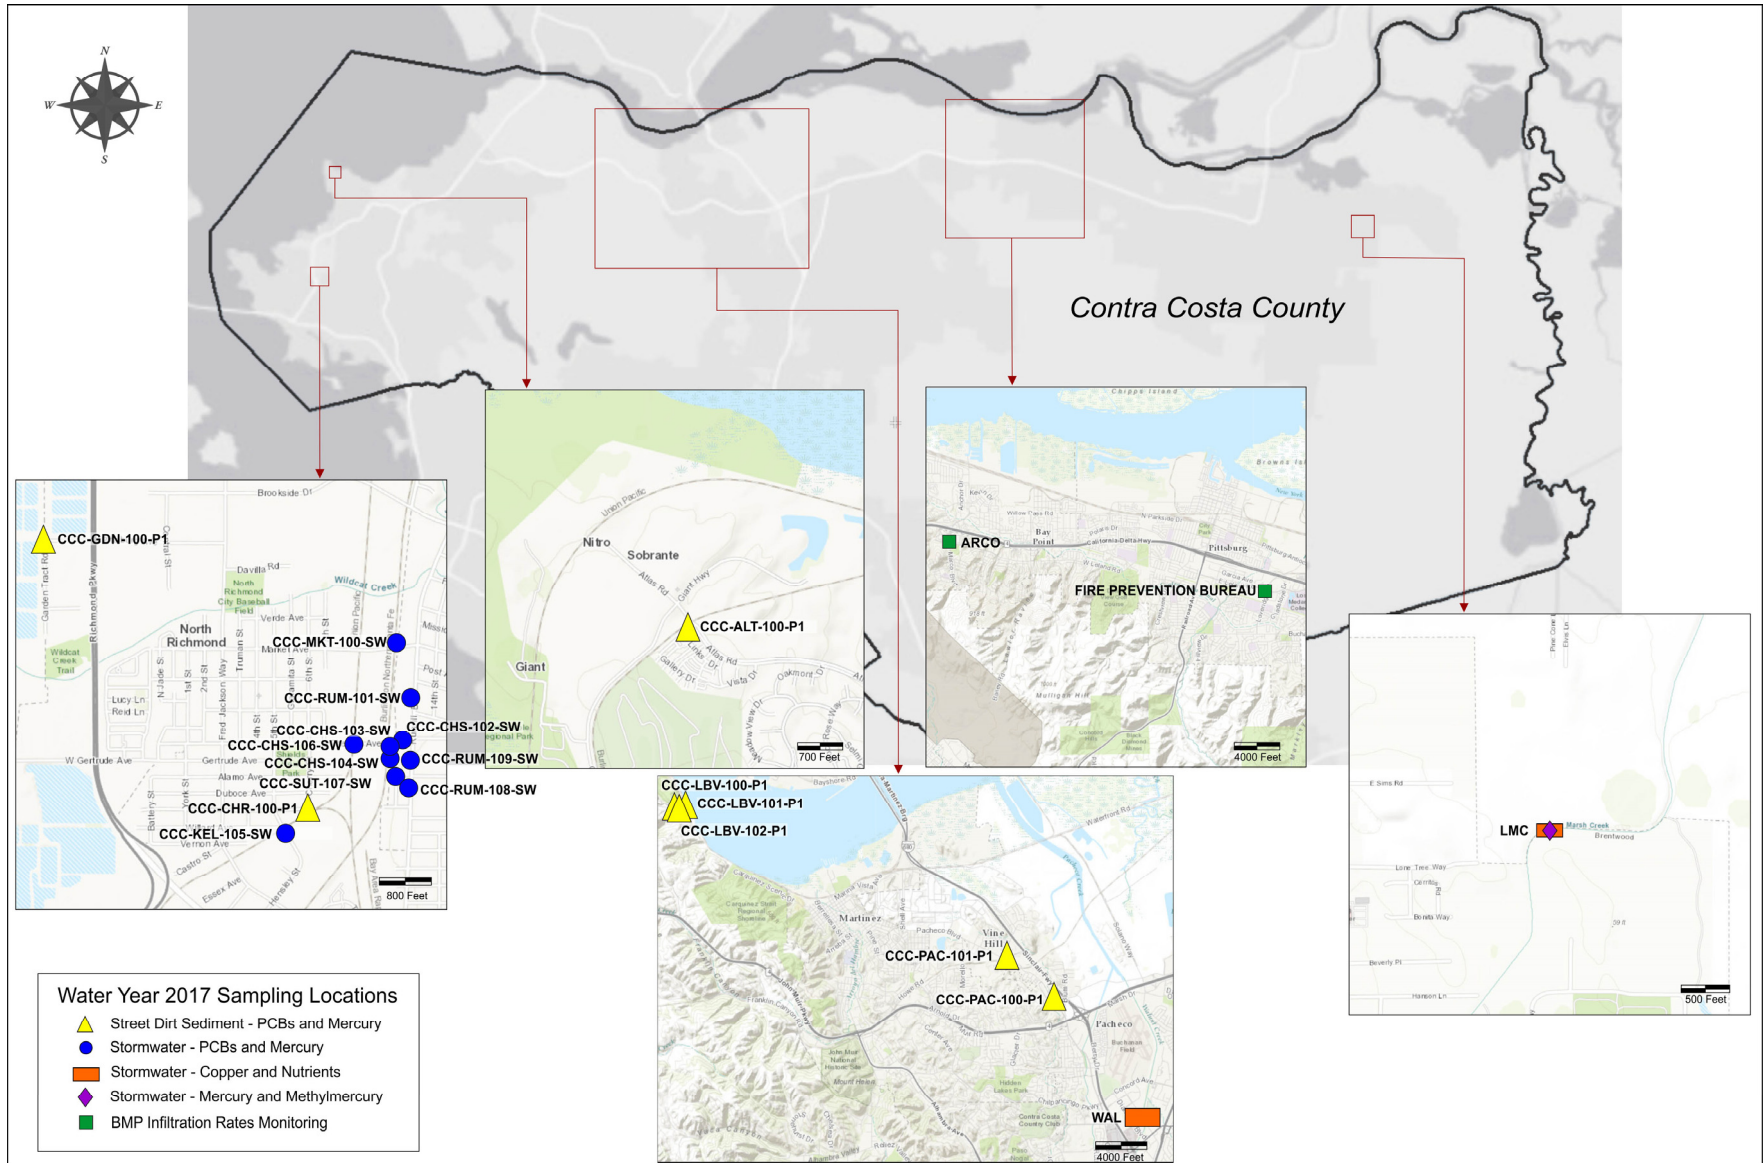
Figure 1. Location of WY 2017 Sampling Points and Monitoring Activities

Refer to Figure 1 for the location of each sampling point or monitoring activity.

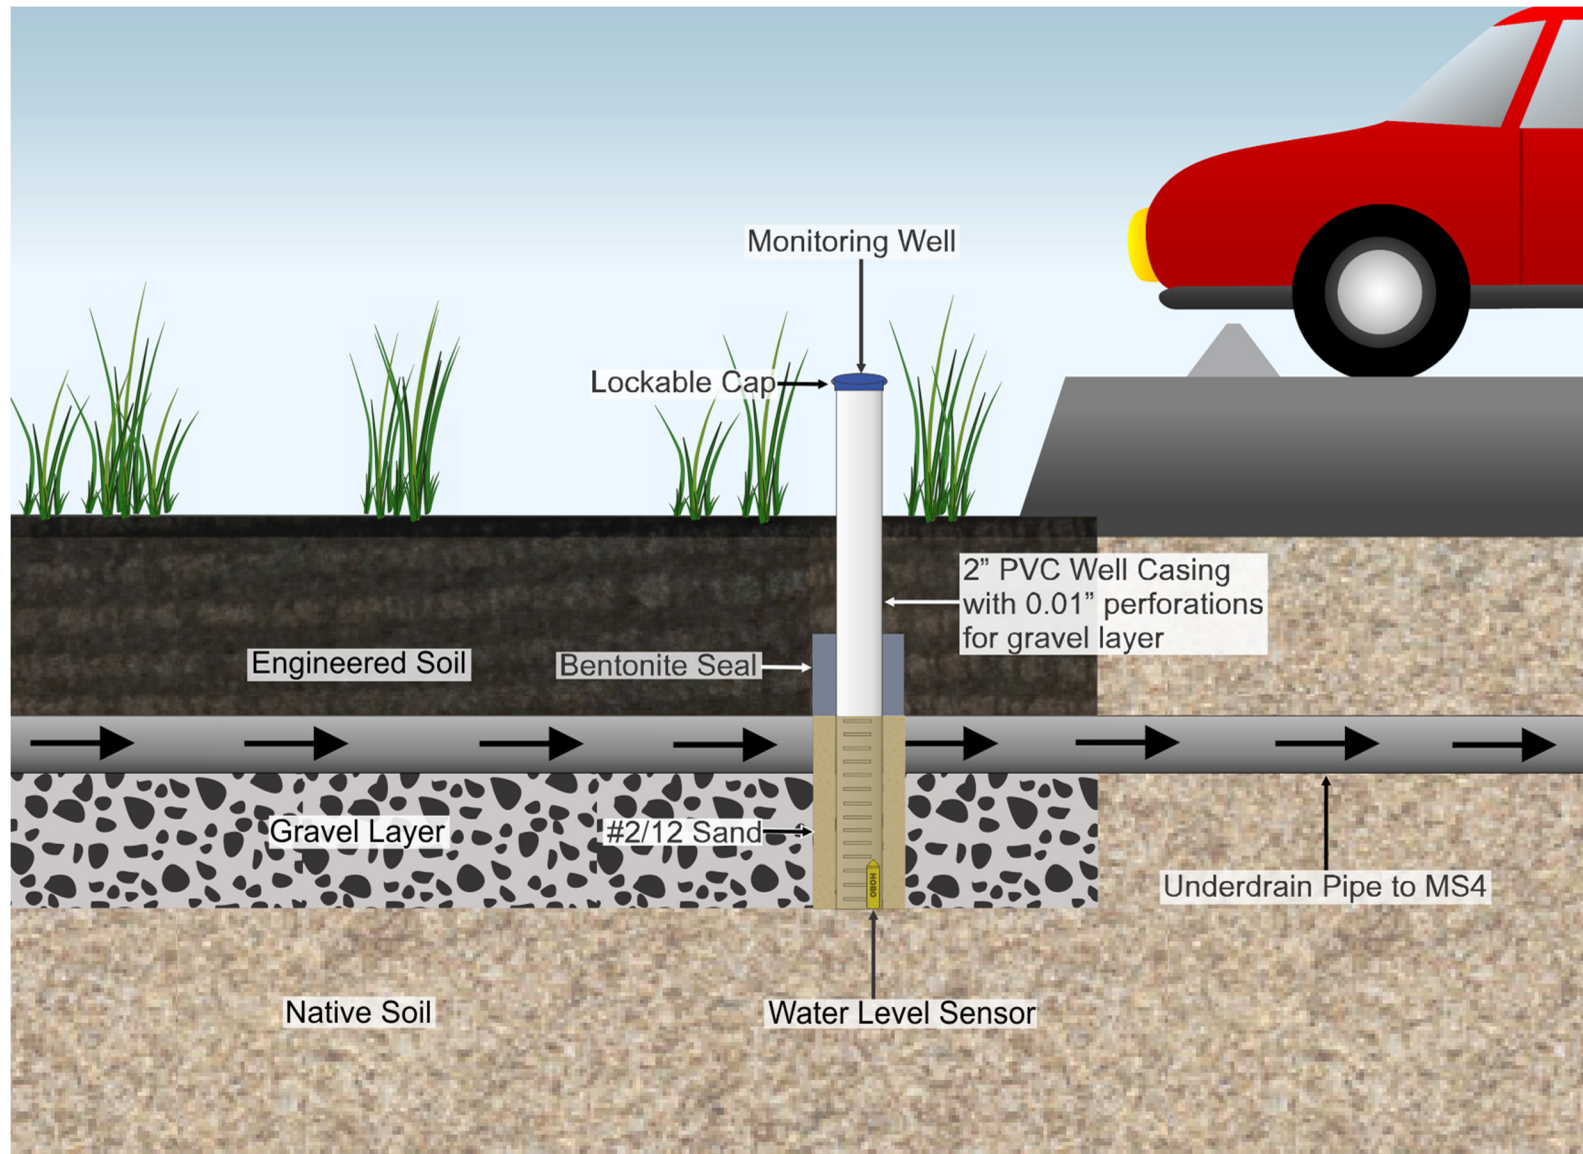
Figure 2. Typical Configuration of Bioretention/Infiltration BMP and Monitoring Well Placement

Monitoring was conducted at six bioretention BMPs to help inform management decisions regarding the efficacy of infiltration as a means of reducing or eliminating discharge of pollutants. Three existing BMPs were monitored at the Fire Prevention Bureau in Pittsburg, and three newly constructed BMPs were monitored at a commercial gas station, also in Pittsburg. The typical configuration of a bioretention/infiltration BMP is depicted in Figure 2.

Each of the three BMPs was constructed in the same general manner: after rilling of the subsurface soil, a layer of gravel and 18 inches of sand/compost mix were placed. The monitoring wells were composed of sections of 3-inch-diameter PVC pipe mounted vertically through the sand/compost and gravel layers with their lowest ends resting at the bottom of the gravel layer. In the 2011-2013 study, the three wells were designated as Integrated Management Practice or IMP 2, IMP 4, and IMP 6. During the recent 2017 study, the wells were designated as Stations A-2, A-4, and A-6, and the water levels were recorded by OnSet® Corporation HOB0® U-220 data loggers.

Each of the three BMPs was constructed in a similar manner: after rilling of the subsurface soil, 12 inches of gravel and then 18 inches of sand/compost mix were placed in layers. The monitoring wells were composed of sections of 8-inch diameter PVC pipe mounted vertically through the sand/compost and gravel layers with their lowest ends resting at the bottom of the gravel layer. The monitoring wells were designated as Arco 1, Arco 2, and Arco 3, with the water levels recorded by OnSet® Corporation HOBO® U-220 data loggers.

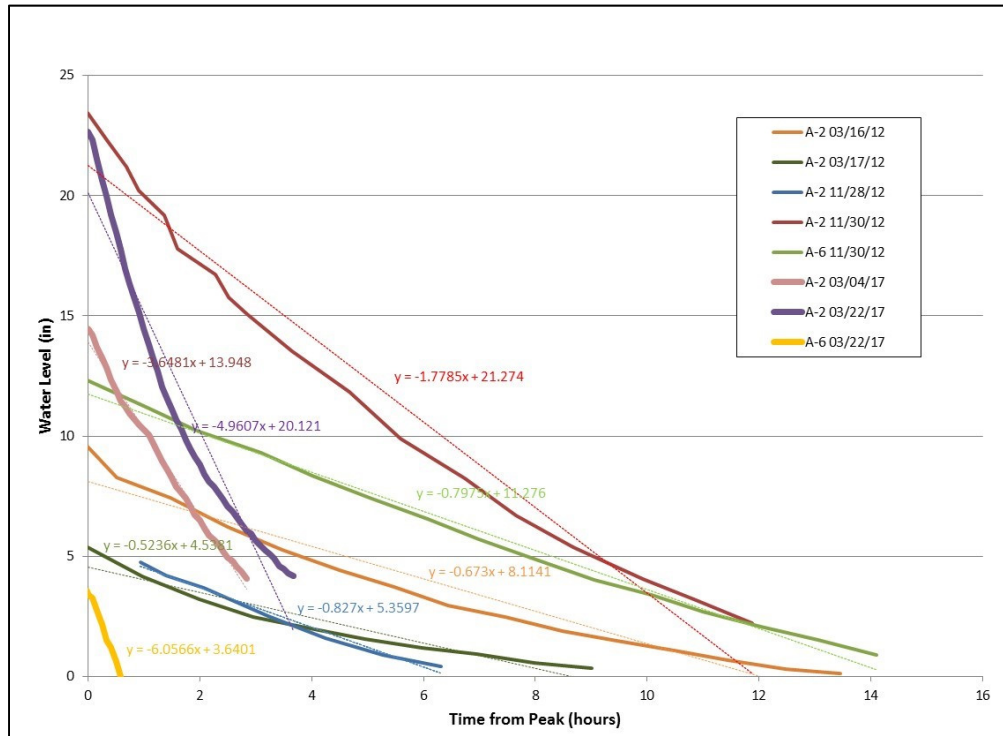
Figure 3. Recession Rates at Fire Prevention Bureau BMPs – Events in 2012 and 2017

The 2011-2013 study (CCCWP, 2013) reported that, following significant storms, accumulated water receded from the gravel layer at a rate of 0.8 inches per hour at Station A-6, and 0.8 to over 1.0 inches per hour at Station A-2. Figure 3 shows the infiltration rates at Stations A-2 and A-6 during various storms occurring in 2012 and 2017. Note the simple linear recession rates (i.e., the slopes of the fitted lines) at both Stations A-2 and A-6 were much greater in the February to April 2017 monitoring period than those reported from 2011-2013, by as much as a factor of five or six. It is not clear why this difference in recession rates exists. The purpose of this study was only to compare the rates.

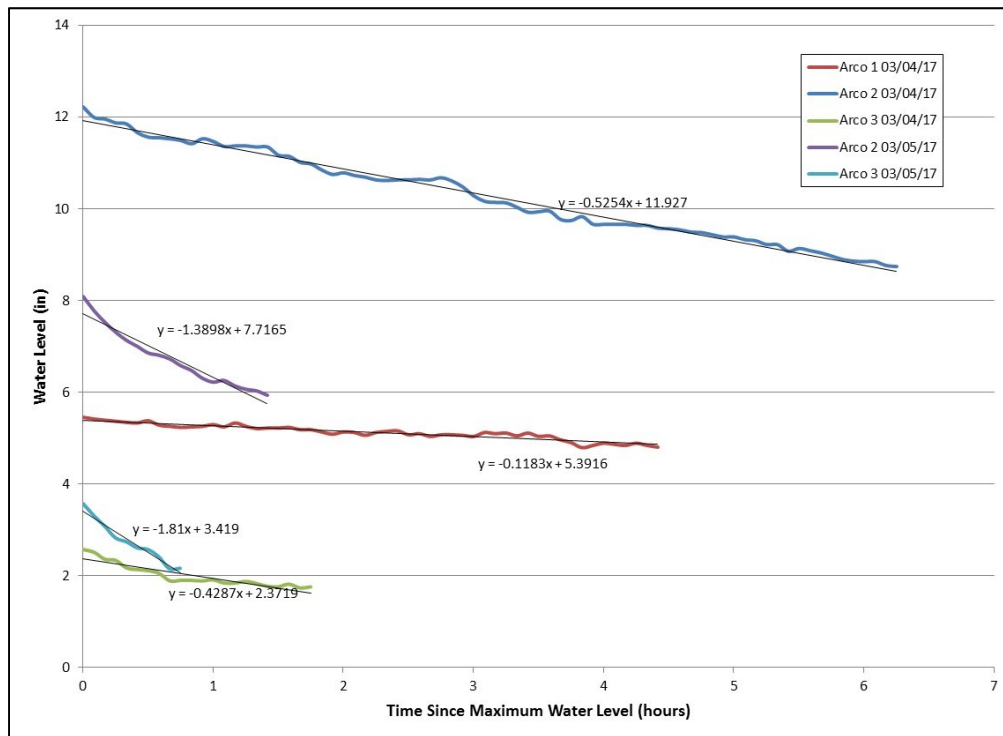
Figure 4. Recession Rates at Arco Gas Station BMPs – March 4-5, 2017

The recession rates for two time periods are presented for storms occurring on March 4-5 and March 22, 2017 in Figures 4 and 5. Each station (Arco 1 through Arco 3) accumulated stormwater which percolated down to the gravel layer during storm events. The simple linear approximations of recession rates indicate the following for the stations at this location:

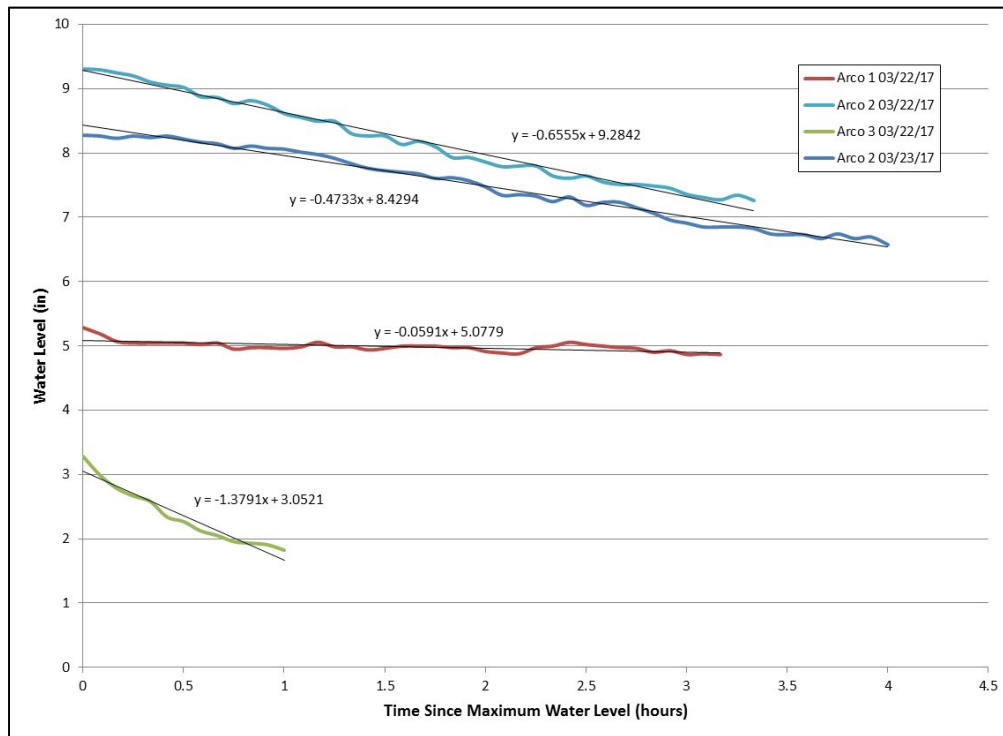
Figure 5. Recession Rates at Arco Gas Station BMPs – March 22, 2017
