CITY OF SAN RAMON

Enclosed is the Fiscal Year 2021-22 Annual Report for the City of San Ramon, which is required by and in accordance with Provision C.17 in National Pollutant Discharge Elimination System (NPDES) Permit Number CAS612008 issued by the San Francisco Bay Regional Water Quality Control Board.

Section 1 – Permittee Information

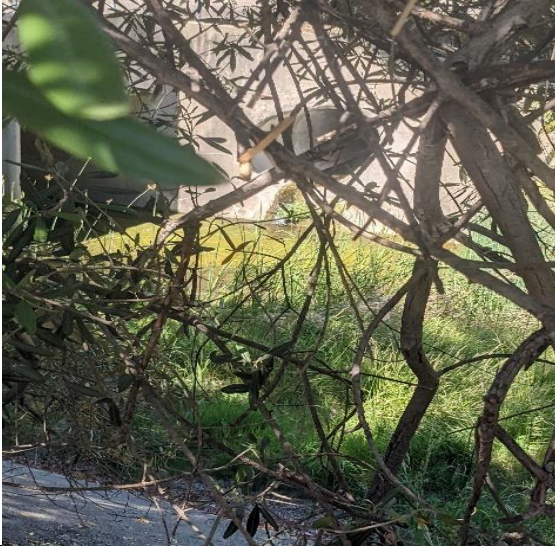
Photo_001
Coyote creek and MS4 outfall near Alcosta Blvd.

Little to no trash was observed on Alcosta Blvd. near the San Ramon golf course and along the section of roadway where Coyote Creek flows beneath Alcosta Blvd (37.73144, -121.92849). In addition, both side of Coyote creek (north and south of Alcosta Blvd) were free of trash and or litter items (see photos 1 to 3 in the photo log).

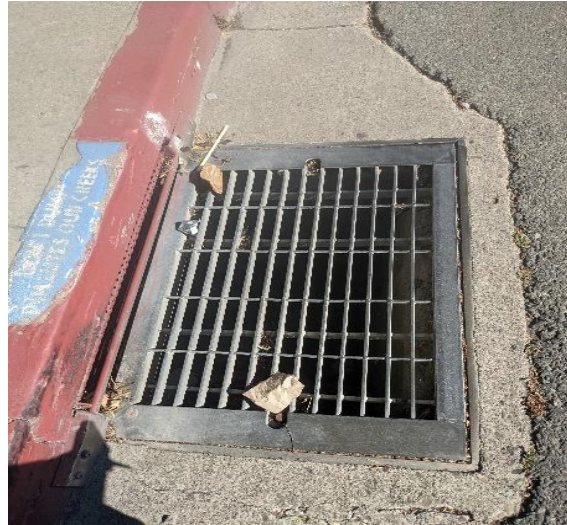
Photo_004
Stormdrain inlet at the intersection of Mangos Dr. and Ensenada Dr

Water Board staff visually inspected the inlet based trash control devices along Mangos Dr. from Ensenada Dr. (37.74685, -121.94151) to De Anaza Pl (37.74747, -121.95196). With the exception of a few paper items and leaf debris (see photos 4 and 5 in the photo log) the inlet based devices in these area appeared to be in good working condition.

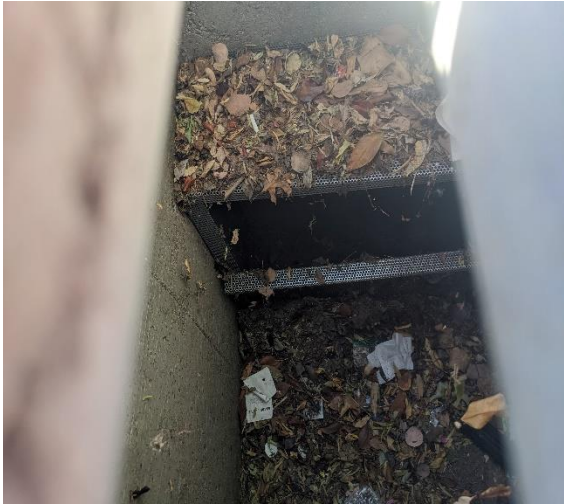
Photo_005

Leaf and trash debris within the stormdrain inlet device at the intersection of Mangos Dr. and Ensenada Dr.

MRP Provision C.10.b.i requires Permittees to inspect, maintain, and retain records of their full trash capture systems. This includes requirements to:
