**Station 1 – Parking Lot on Lincoln Ave (DAN)**

### **Station 2 – East edge of Parking Lot by Creek (MEGAN)**

### **Station 3 – Planter next to building (RINTA)**

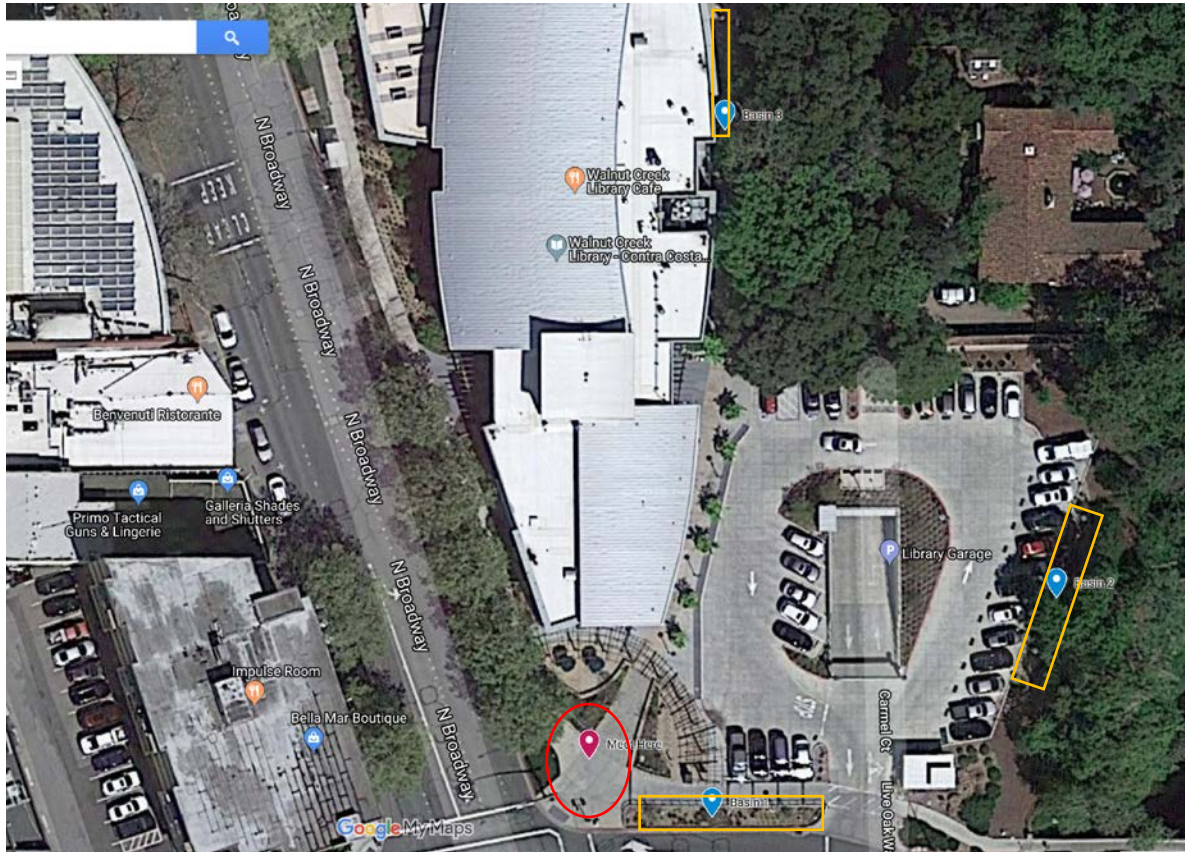
- Is this bioretention or flow through? (bioretention, probably)
- Point out or Ask people to point out the parts:
  - Inlets (both from lot and into basin)
  - scour protection,
  - Overflow,
  - cleanout,
  - grasses,
  - trees,
  - rock mulch,
  - spray irrigation, bubblers for trees
- What would you do here to maintain?
  - Debris in inlet at west corner of parking lot
  - Trash?
  - Plants (sedges) look generally good. These can be cut back every few years but not required. Can be divided and replanted if bare areas.
  - Some plants not thriving – why? Investigate if irrigation is blocked by healthier plants. If only one plant is not doing well, its ok.

- Trees look healthy, yay
- Direct people to station 2 (East edge of parking lot by creek)

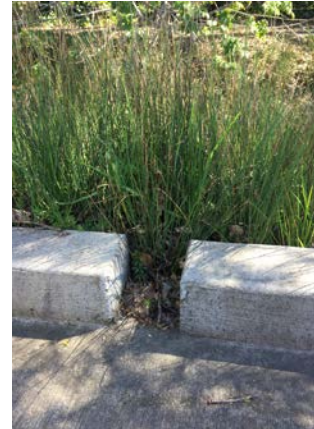
- Is this bioretention or flow through? (bioretention)
- Point out or Ask people to point out the parts:
  - Inlets
  - Overflow,
  - cleanout,
  - grasses,

- rock mulch,
  - spray irrigation
- What would you do here to maintain?
  - Weeds at the south end – optional to pull by hand, they are not impeding function

- Several inlets are blocked by healthy juncus. These can be dug up and relocated. Then add rock mulch at the inlets making sure to leave a 1-2” drop right at the inlet to allow for sediment to accumulate.

- Trash
  - The inlet at the north end is not blocked but there is evidence of erosion. See headcut coming up from bottom of basin and accumulation of sediment in bottom of basin. Overtime this area of basin may clog. Consider removing top 2-3” and replacing with biotreatment soil mix and rock mulch.

- Cleanout getting buried by gravel above
  - Otherwise plants very healthy, no need to cut back
  - Overflow has a few leaves but nothing major
  - Leaf litter is ok to leave

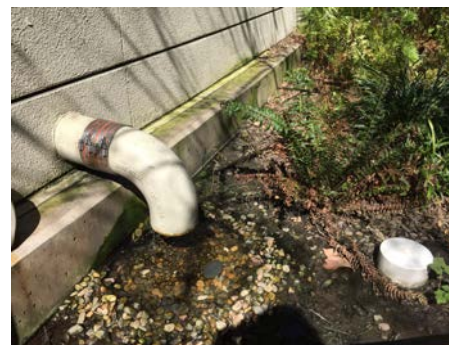
- Is this bioretention or flow through planter? (flow through planter)
- Point out or ask people to point out the parts:
  - Inlets
  - Overflow,
  - cleanout,
  - plants & trees
  - rock mulch,
  - irrigation

- This basin receives air conditioning effluent
  - Splash bocks are concrete
- What would you do here to maintain?
  - Plants are generally healthy, area of rubus is somewhat thin but could be time of year

- Very healthy Japanese Maples are probably due to the A/C effluent providing extra water
  - Is this basin on a separate valve from other irrigation? Consider limiting the watering schedule to save water unless all the flow-through planters are on same valve.

- Trash
  - Generally, flow-through planters have less input of sediment and trash
  - This basin is in the shade which is a big benefit to the plants because of fast draining soils. Flow-through planters on south facing buildings get hammered with direct and reflective light and often become sand pits. Try very drought resistant plants in those types of basins.

- Appears that there is also fire sprinkler flushing effluent into one planter
- Mention Bioretention on the opposite side of building (along Broadway) gets more sun. After field walk is done, people can walk past it on their own to compare and contrast the plant health. Wouldn't it be nice if the air-conditioning & fire effluent happened on the sunny side? Designers...
